WL-TR-96-4030

**PROCEEDINGS OF
THE 1994 USAF
STRUCTURAL INTEGRITY
PROGRAM CONFERENCE**

USAF Structural Integrity Program Conference
Hyatt Regency
San Antonio, Texas

Final Report for Period 6 - 8 December 1994

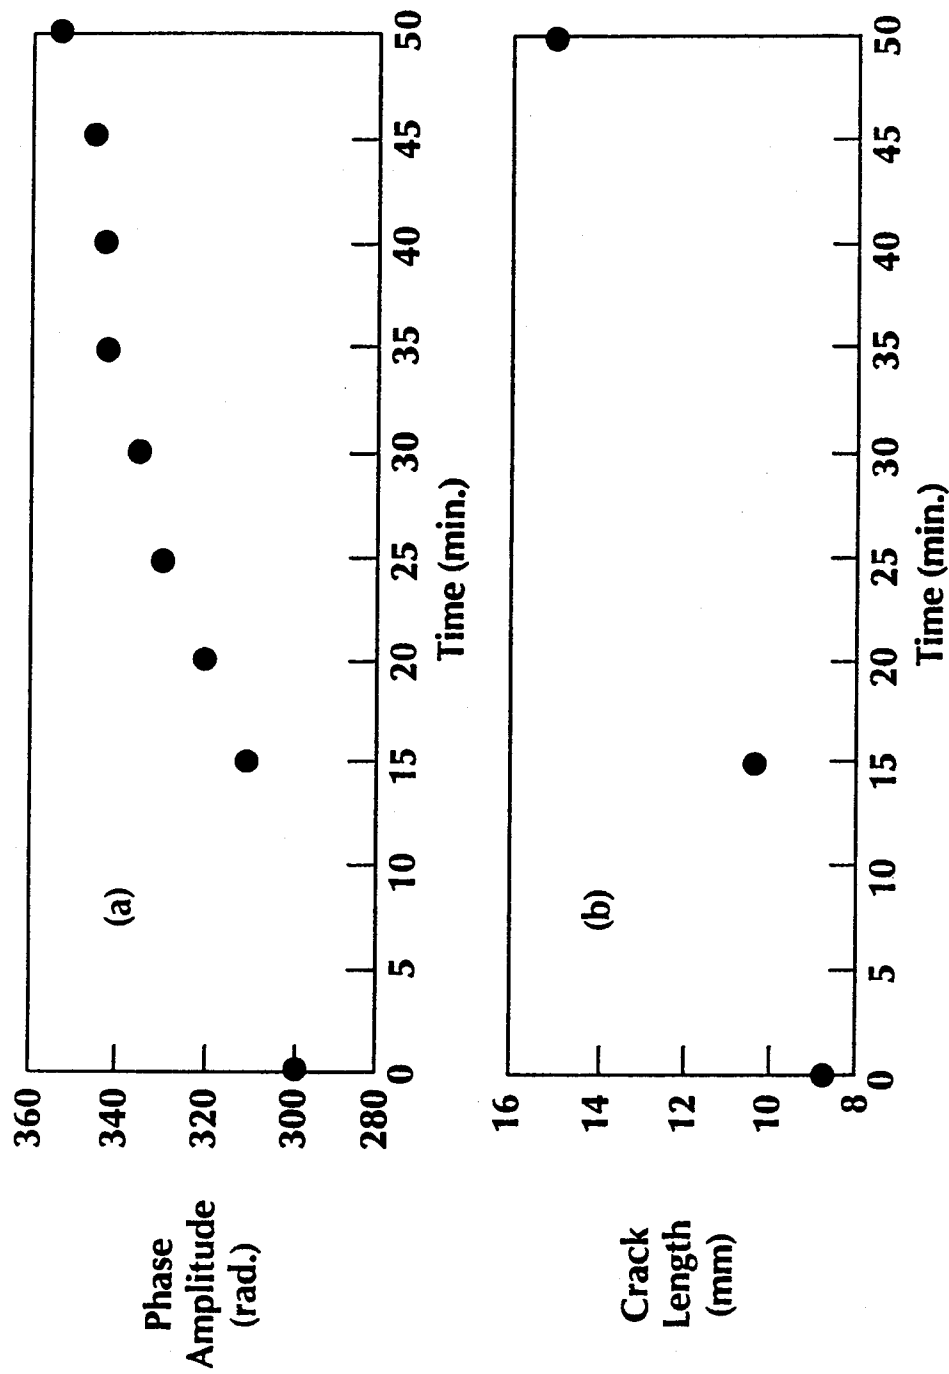
Figure 5. Phase Amplitude and Crack Length vs Time

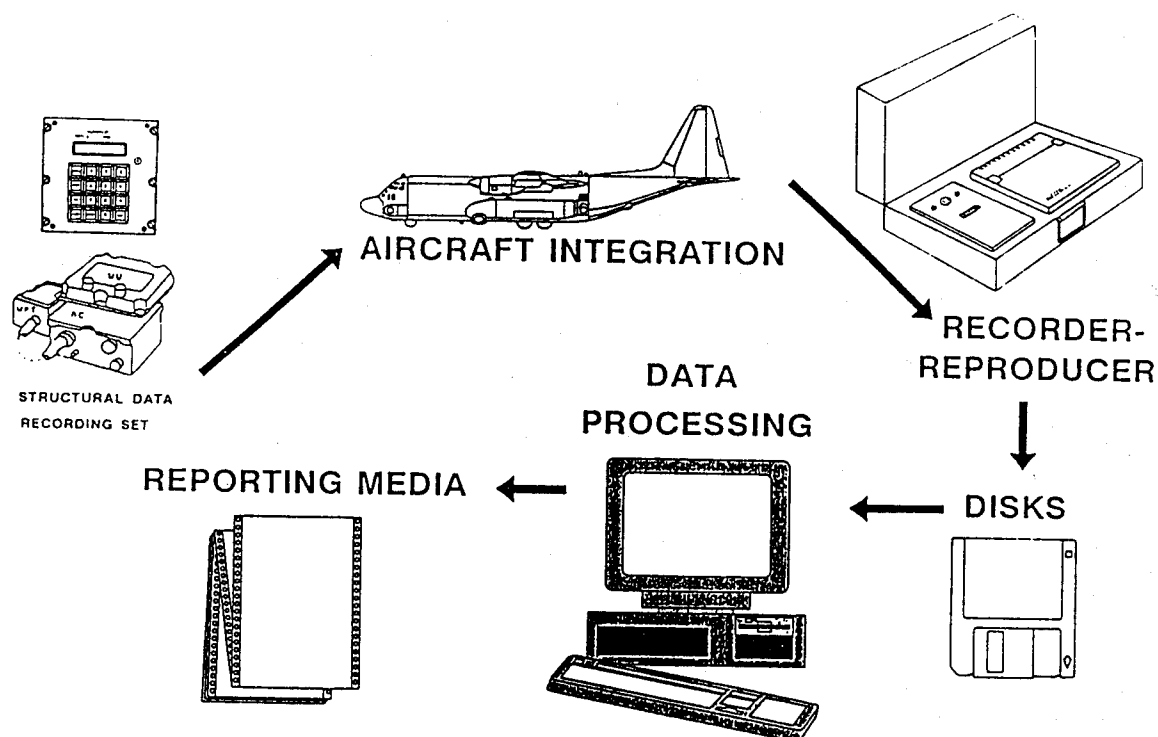
Fig. 1 ASH-37 Flight Data Recording System

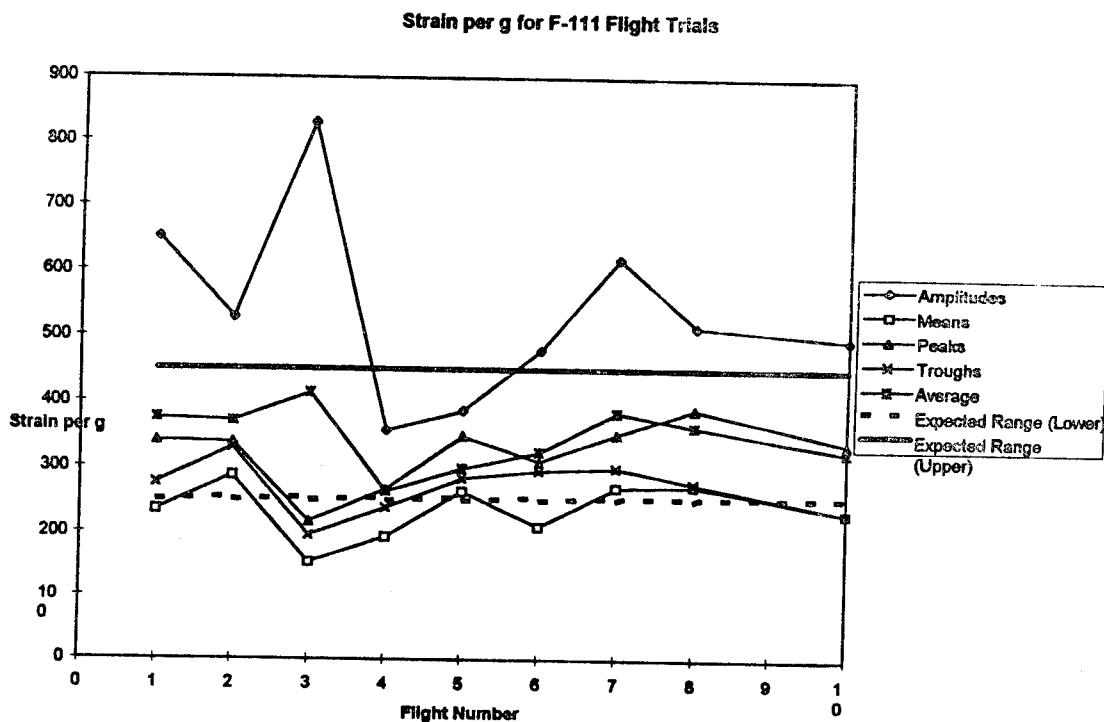
FIGURE 5: STRAIN PER G RESULTS F-111 1987 FLIGHT TRIALS

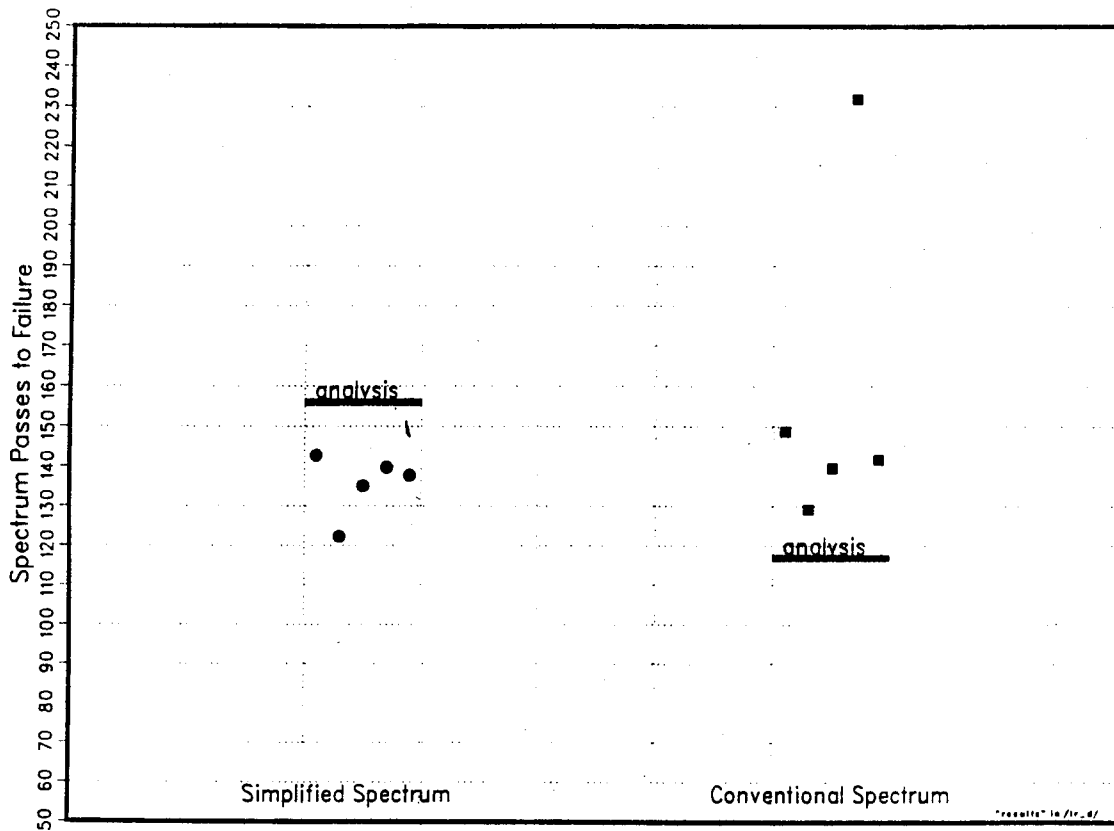
Figure 3.1.3.1-1 Test and Analysis Results, Spectra Without Negative Loads
